**Flood Control Project Maintenance
Levee Inspections**

Fall 2015 Levee Maintenance Deficiency Summary Report

Sacramento River Basin

Sacramento Maintenance Yard Putah Creek

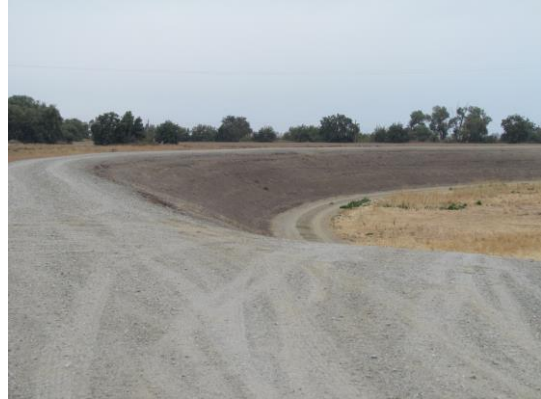
Photo 1 of 1 : FA_2015_ST0007_282_22_20151006_00006.jpg

LM Start	0.00	Rating **	A	Issue No.	22
LM End	8.52	Issue Type +	Ma	Location *	LS
Category	Earthen Levee			GPS Latitude/Longitude	
				Start	End
Item	Vegetation			38.523630 °	38.523227 °
				-121.631460 °	-121.780180 °
DWR ID	DWR_ST0007_01_f_2015_22				
Action/Comments					
Control annual grass and weeds on the levee slopes and easements. Inspector Comments: Maintaining Agency has burned and dragged the landside slope.

Putah Creek looking downstream from levee mile 0.00 landside levee slope.

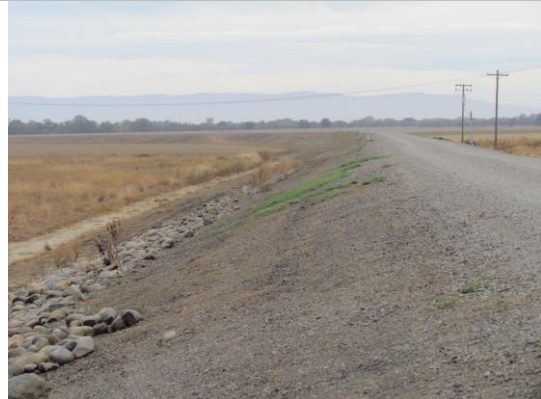
Photo 1 of 1 : FA_2015_ST0007_282_24_20151006_00005.jpg

LM Start	0.00	Rating **	A	Issue No.	24
LM End	8.52	Issue Type +	Ma	Location *	WS
Category	Earthen Levee			GPS Latitude/Longitude	
				Start	End
Item	Vegetation			38.523630 °	38.523227 °
				-121.631460 °	-121.780180 °
DWR ID	DWR_ST0007_01_f_2015_24				
Action/Comments					
Control annual grass and weeds on the levee slopes and easements. Inspector Comments: The maintaining agency has both burned and dragged the waterside levee slope.

Putah Creek looking downstream from levee mile 0.00 waterside levee slope.

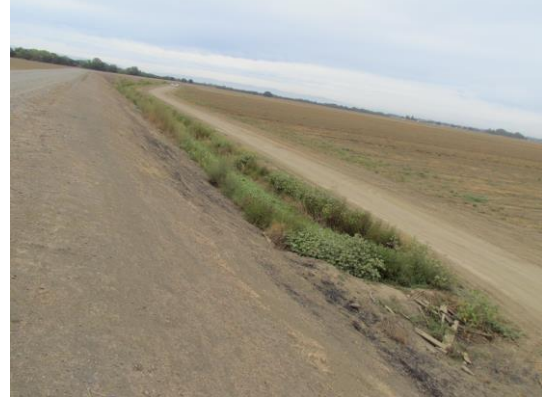
Photo 1 of 1 : FA_2015_ST0007_282_10_20151006_00004.jpg

LM Start	1.48	Rating **	U	Issue No.	10
LM End	2.67	Issue Type +	En	Location *	LS
Category	Earthen Levee			GPS Latitude/Longitude	
				Start	End
Item	Encroachments			38.515322 °	38.517376 °
				-121.654387 °	-121.676054 °
DWR ID	DWR_ST0007_01_s_2012_10				
Action/Comments					
Ditch					
Inspector Comments: This agriculture ditch is owned by Dos Rios Farms. Ending at levee mile 2.72 landside.

Agriculture ditch within 10-foot of levee toe.

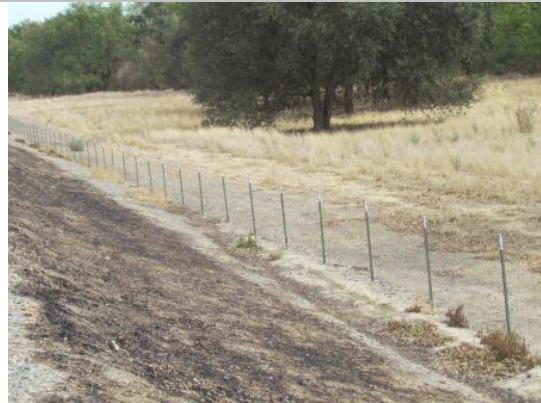
Photo 1 of 1 : FA_2015_ST0007_282_4_20150915_00001.jpg

Action/Comments					
Fence Inspector Comments: No permit for this wire fence waterside levee slope.

Wire fence within 10-foot easement waterside levee slope.

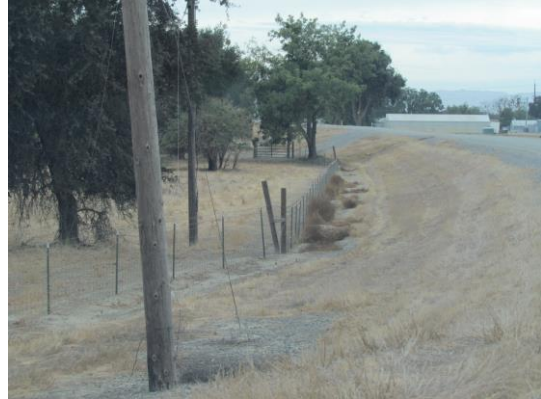
Photo 1 of 1 : FA_2015_ST0007_282_33_20151006_00007.jpg

LM Start	3.33	Rating **	U	Issue No.	33
LM End	3.39	Issue Type +	En	Location *	WS
Category	Earthen Levee			GPS Latitude/Longitude	
				Start	End
Item	Encroachments			38.519957 °	38.520033 °
				-121.687738 °	-121.688813 °
DWR ID	DWR_ST0007_01_f_2015_33				
Action/Comments					
Fence					
Inspector Comments: This is not a new encroachment.

Fence within the 10-foot easement waterside levee toe.

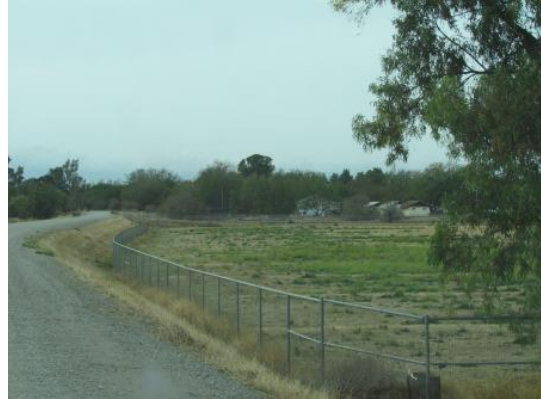
Photo 1 of 1 : FA_2015_ST0007_282_5_20150915_00002.jpg

LM Start	6.63	Rating **	M	Issue No.	5
LM End	6.71	Issue Type +	En	Location *	LS
Category	Earthen Levee			GPS Latitude/Longitude	
				Start	End
Item	Encroachments			38.517746 °	38.517647 °
				-121.747220 °	-121.748679 °
DWR ID	DWR_ST0007_01_s_ 2012_5				
Action/Comments					
Fence					
Inspector Comments: This fence has been in the area for many years. Levee mile 6.70-6.84 landside within10-foot of easement. No new photo was taken.

Fence at levee mile 6.76 to 6.84 landside within 10-foot of landward toe.
Not a new encroachment.

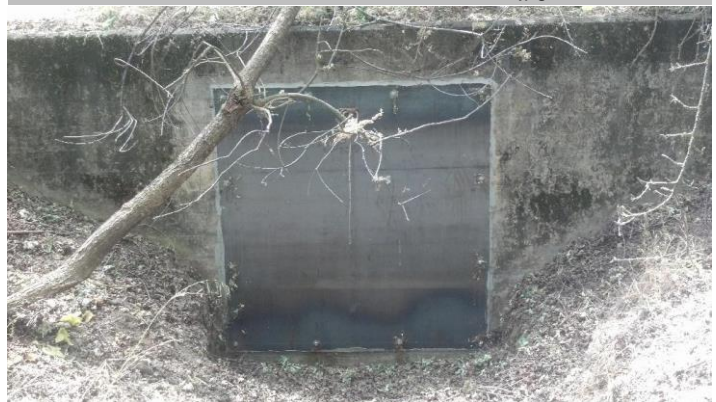
Photo 1 of 1 : UCIP_FA_2015_3654.jpg

LM Start	8.69	Rating **	M	Issue No.	55
LM End	8.69	Issue Type +	En	Location *	WS
Category	Supplemental			GPS Latitude/Longitude	
				Start	End
Item	DWR UCIP Field Study			38.523999 °	38.523999 °
				-121.783037 °	-121.783037 °
DWR ID					
Action/Comments					
Inspector Comments: FS_ID:41129 DS_ID:523 EP_NO: 10247 FS_HLM: 8.87 Repair Type: Non-Urgent Crossing Status: Found UCIP Comments: *ABANDONED* FIELD_STRUCT_DESC: *ABANDONED* 48-inch drain pipe through the levee 15.0 feet below the crown. Steel plate installed over inlet off LS toe (pipe not grouted). Flap gate on waterward end. Headwall on both ends. (ABO No.10247 U.C.D.) FS Date: 04/10/2014

Steel plate installed over pipe off LS toe.

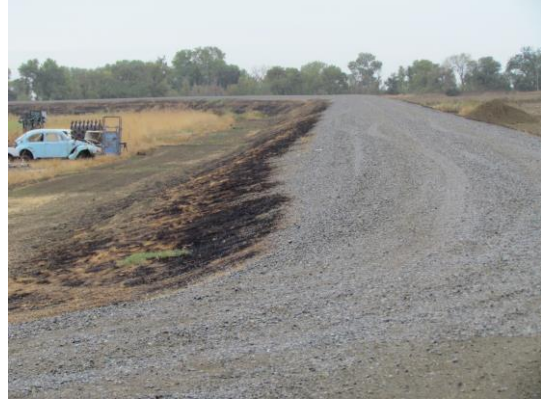
Photo 1 of 1 : FA_2015_ST0007_283_17_20151006_00005.jpg

LM Start	0.02	Rating **	A	Issue No.	17
LM End	0.55	Issue Type +	Ma	Location *	LS
Category	Earthen Levee			GPS Latitude/Longitude	
				Start	End
Item	Vegetation			38.505045 °	38.510265 °
				-121.663118 °	-121.667545 °
DWR ID	DWR_ST0007_02_f_2015_17				
Action/Comments					
Control annual grass and weeds on the levee slopes and easements. Inspector Comments: Burned and dragged.

Putah Creek looking downstream from levee mile 0.00 landside levee slope.

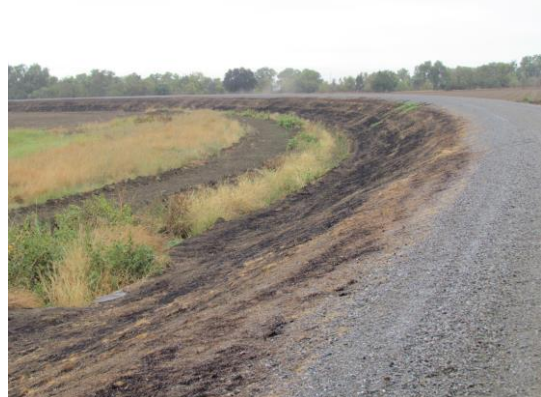
Photo 1 of 1 : FA_2015_ST0007_283_3_20151006_00006.jpg

LM Start	0.18	Rating **	U	Issue No.	3
LM End	0.31	Issue Type +	En	Location *	LS
Category	Earthen Levee			GPS Latitude/Longitude	
				Start	End
Item	Encroachments			38.507155 °	38.509035 °
				-121.682817 °	-121.663488 °
DWR ID	DWR_ST0007_02_s_2012_3				
Action/Comments					
Ditch					
Inspector Comments: This ditch is within the 10-easement

Agriculture ditch on the landside within the 10-foot easement.

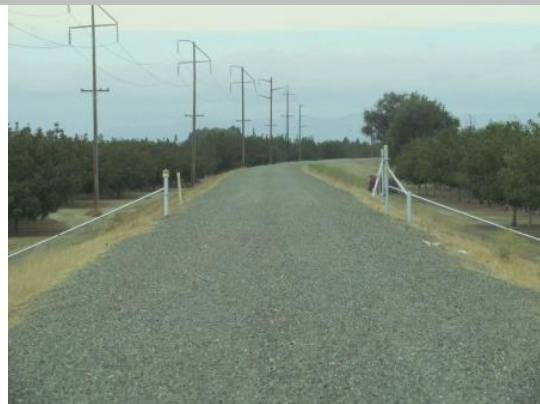
Photo 1 of 1 : FA_2015_ST0007_283_29_20150915_00003.jpg

LM Start	0.55	Rating **	U	Issue No.	29
LM End	0.55	Issue Type +	En	Location *	LS
Category	Earthen Levee			GPS Latitude/Longitude	
				Start	End
Item	Encroachments			38.510249 °	38.510249 °
				-121.667551 °	-121.667551 °
DWR ID	DWR_ST0007_02_s_2013_29				
Action/Comments					
Fence					
Inspector Comments: No new photo taken; this fence does not have a CVFPB Permit.

There is no permit for this fence and gate crossing levee crown roadway.

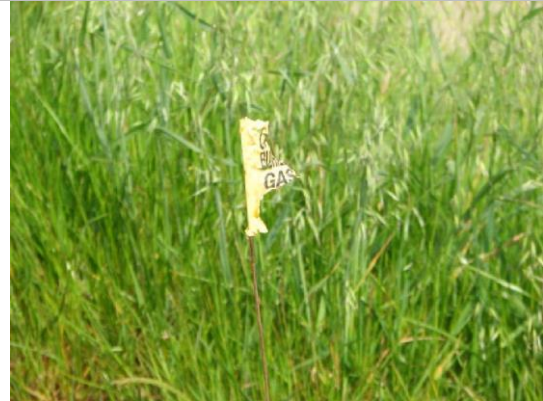
Photo 1 of 3 : UCIP_FA_2015_3498.jpg

Action/Comments					
Inspector Comments: FS_ID:33400					
DS_ID:16623					
EP_NO: 9139					
FS_HLM: 1.64					
Repair Type: Non-Urgent					
Crossing Status: Indicator Found					
UCIP Comments: There are no appropriate gas markers present on levee to indicate pipe location. Markers need to be installed. No danger to the levee					
FIELD_STRUCT_DESC: 8-inch gas line through the levee 3.0 feet below crown under channel and through Unit No. 1 levee. (Permit No. 9139 - DOW)					
FS Date: 04/10/2014

small flag on WS shoulder

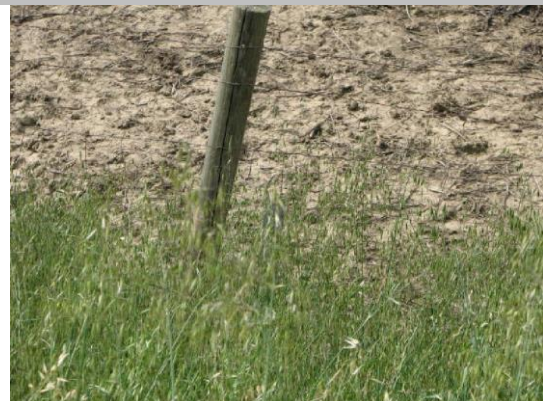
Photo 2 of 3 : UCIP_FA_2015_3499.jpg

steel sign marker at LS toe with no sign

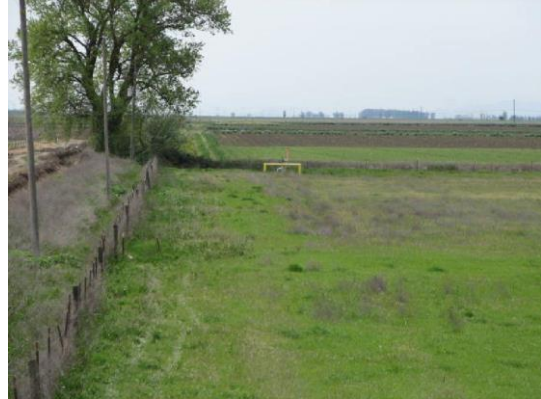
Photo 3 of 3 : UCIP_FA_2015_3500.jpg

LM Start	1.60	Rating **	M	Issue No.	39 (cont)
LM End	1.60	Issue Type +	En	Location *	LS
Category	Supplemental			GPS Latitude/Longitude	
				Start	End
Item	DWR UCIP Field Study			38.514250 °	38.514250 °
				-121.685980 °	-121.685980 °
DWR ID					
Action/Comments					
Inspector Comments: FS_ID:33400					
DS_ID:16623					
EP_NO: 9139					
FS_HLM: 1.64					
Repair Type: Non-Urgent					
Crossing Status: Indicator Found

Gas vent 800-feet to south

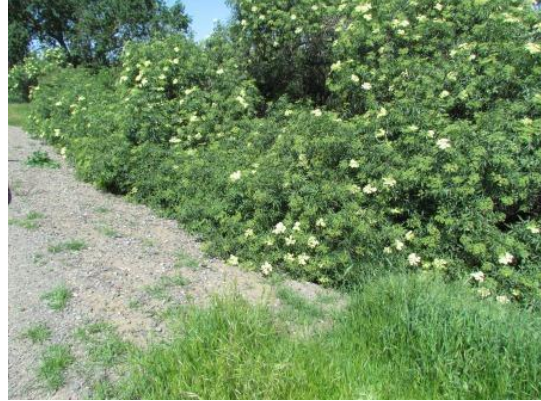
Photo 1 of 1 : FA_2015_ST0007_283_38_20150915_00004.jpg

LM Start	6.78	Rating **	U	Issue No.	38
LM End	6.89	Issue Type +	Ma	Location *	WS
Category	Earthen Levee			GPS Latitude/Longitude	
				Start	End
Item	Vegetation			38.520602 °	38.521467 °
				-121.778191 °	-121.779795 °
DWR ID	DWR_ST0007_02_s _ 2014_38				
Action/Comments					
Elderberries are blocking visibility and flood fight capability. Inspector Comments: These elderberries at this location need to be trimmed.

Looking downstream at elderberry trees blocking the view of the waterward slope and toe. Photo taken 4-15-2014.
